The Consequences of Operating Telehandlers on Soft Ground, Inclines and Unsupported Surfaces.

Telescopic Handler Association of Australia
www.tsha.com.au v1.0 issue June 2020

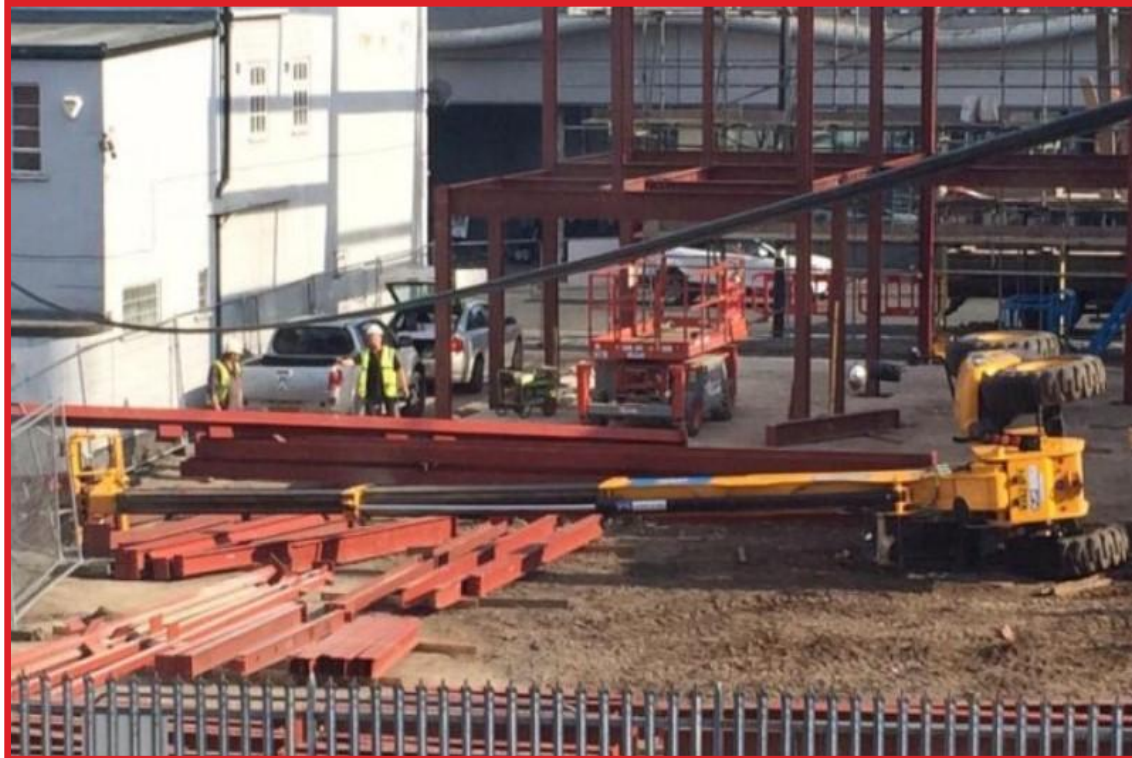
Overturn on worksite- North Wales

Damage to machine and property. Minor injuries.

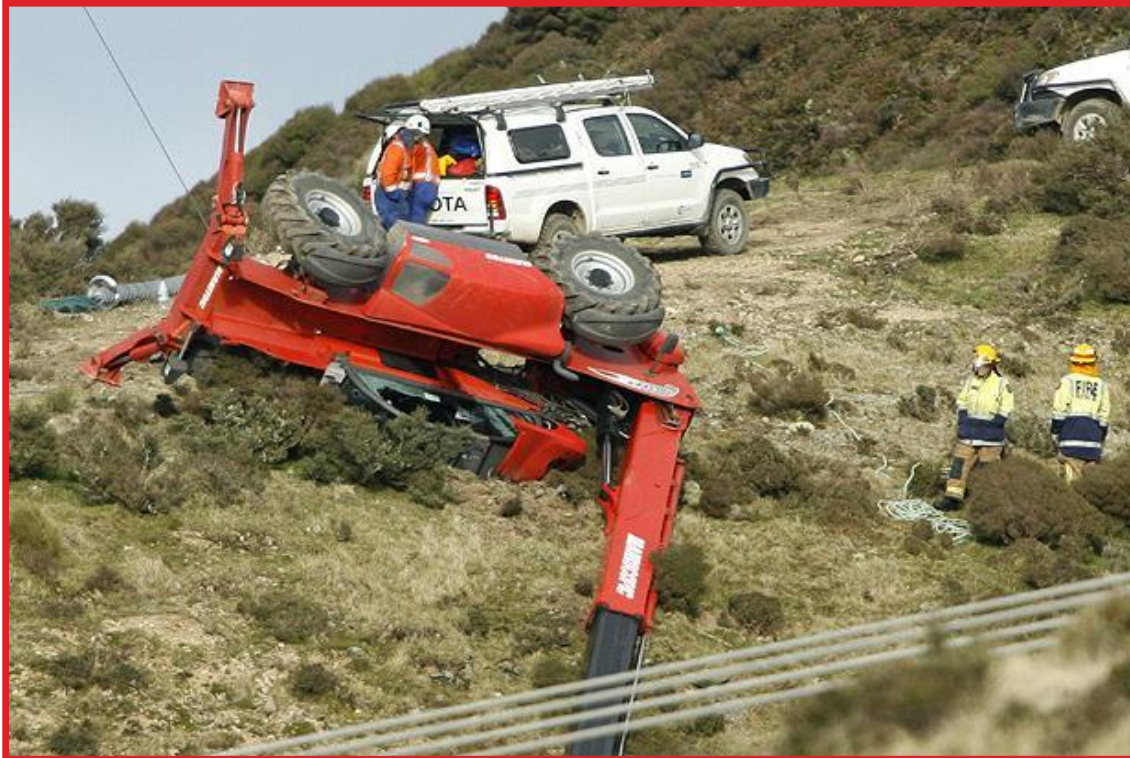
Telehandler fatality – New Zealand
Worker fatally crushed and second worker injured.
<https://vertikal.net/en/news/story/12490/transpower-accident-new-zealand>

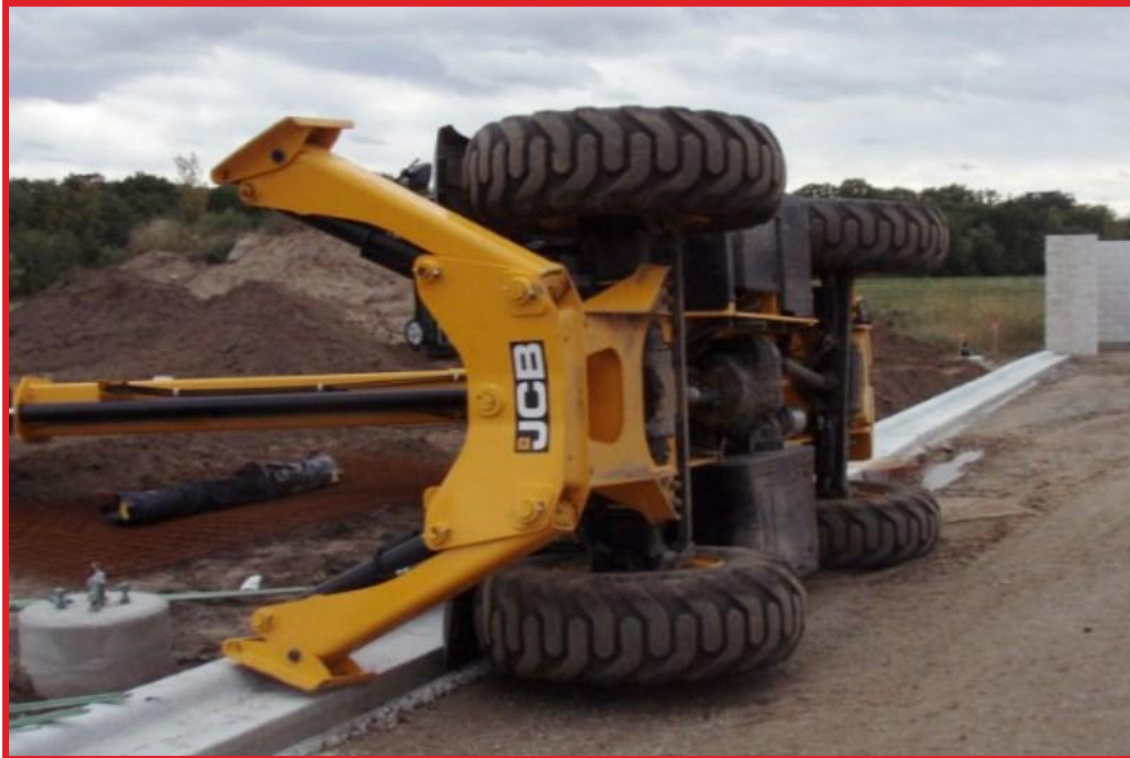
Telehandler overturn – Minnesota

Operator sustained head injury and concussion
